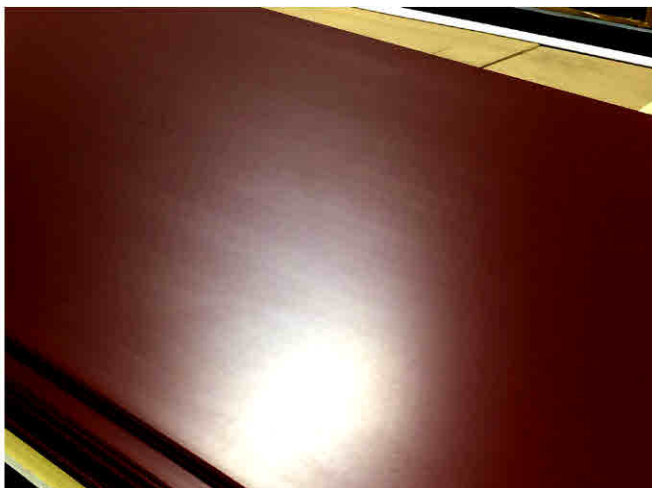
Photo 1

Pressure mottling, also known as pressure marking or imprinting, is an inconsistent gloss pattern in the panel or flat sheet. Pressure mottling is flattening of the top coat (figure 1) which will appear as horizontal stripes in the panel face (photo 1) or a random pattern in the flat sheet (photo 2). Pressure mottling is normally caused by the stacked weight of the bundles or panels, but high temperatures and condensation in the stack can cause this also. This phenomena is most visible in dark, low gloss colors on non-embossed no profile panels or flat sheets. This is not a product defect and will dissipate over time. The coating will recover within a few days after the material is exposed to sun light or warm exterior temperatures (figure 2).

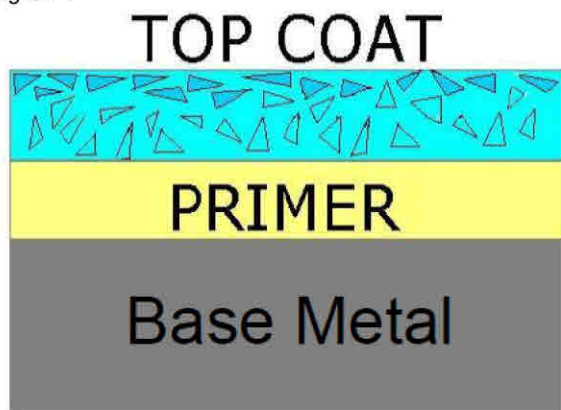
Figure 1

Sample crossview showing
"suppressed" gloss components

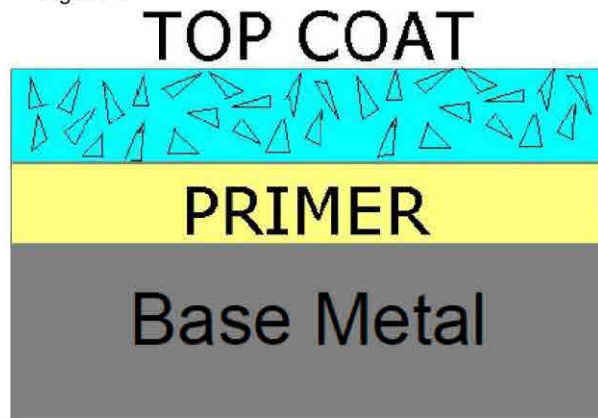
Figure 2

Sample crossview showing gloss
components in normal suspension
