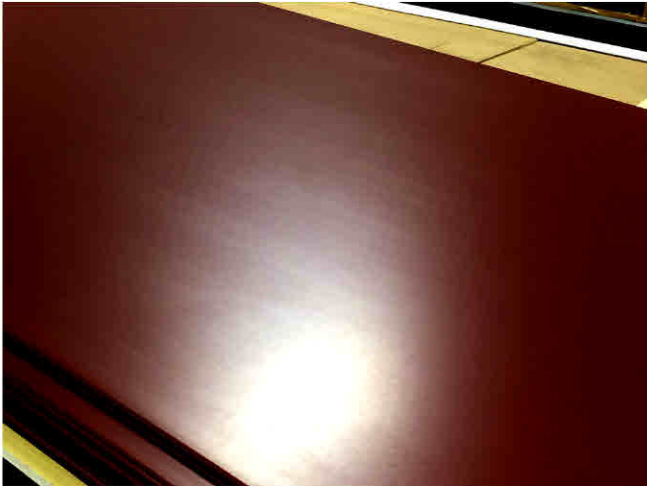
Photo 1

Pressure mottling, also known as pressure marking or imprinting, is an inconsistent gloss pattern in the panel or flat sheet. Pressure mottling is flattening of the top coat (figure 1) which will appear as horizontal stripes in the panel face (photo 1) or a random pattern in the flat sheet (photo 2). Pressure mottling is normally caused by the stacked weight of the bundles or panels, but high temperatures and condensation in the stack can cause this also. This phenomena is most visible in dark, low gloss colors on non-embossed no profile panels or flat sheets. This is not a product defect and will dissipate over time. The coating will recover within a few days after the material is exposed to sun light or warm exterior temperatures (figure 2).

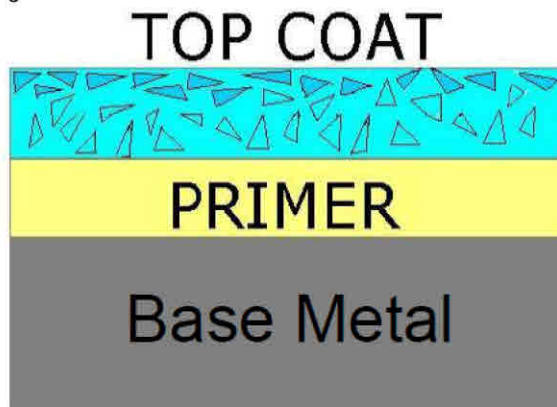
Figure 1

Sample crossview showing  
"suppressed" gloss components

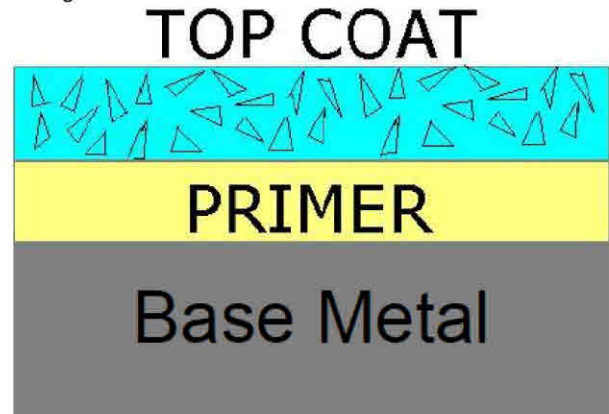
Figure 2

Sample crossview showing gloss  
components in normal suspension
