STAINING OF BUILDING PANELS FROM STEEL DEBRIS

TBP 2005.1

Job Site Imperfections

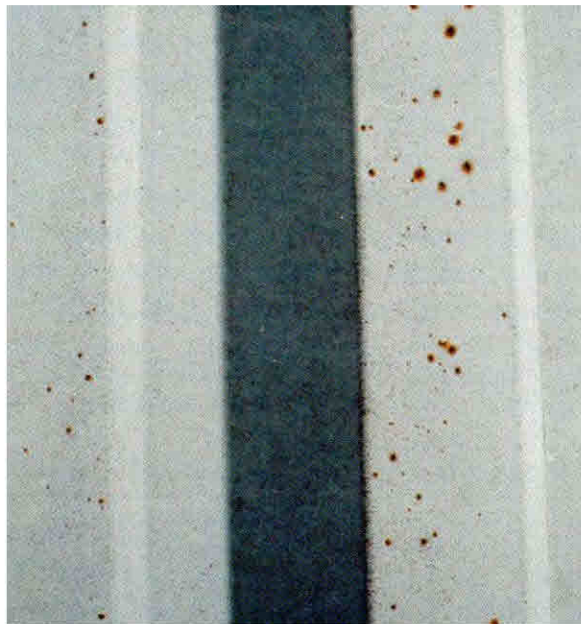
Fresh steel debris stains are small red-brown colored spots with a central dark spot (the remains of the steel particle). Steel corrosion eliminates fine steel debris within a couple of years on painted panels. The stain will remain long after the metallic iron has rusted away. The panel feels rough from loose or embedded particles. On bare panels, galvanic action protects the debris, possibly depleting the metallic coating in the immediate vicinity. An old steel debris stain will appear as a smoother surface with a localized red-brown stain in the area where the steel particle corroded away. Iron fines from drilling cause groups of stain spots around the hole. Cutting often causes a line of stain spots along the cut. Tracked particles cause randomly dispersed spots on the roof. Inadequate washing moves particles to the inside of the profile.

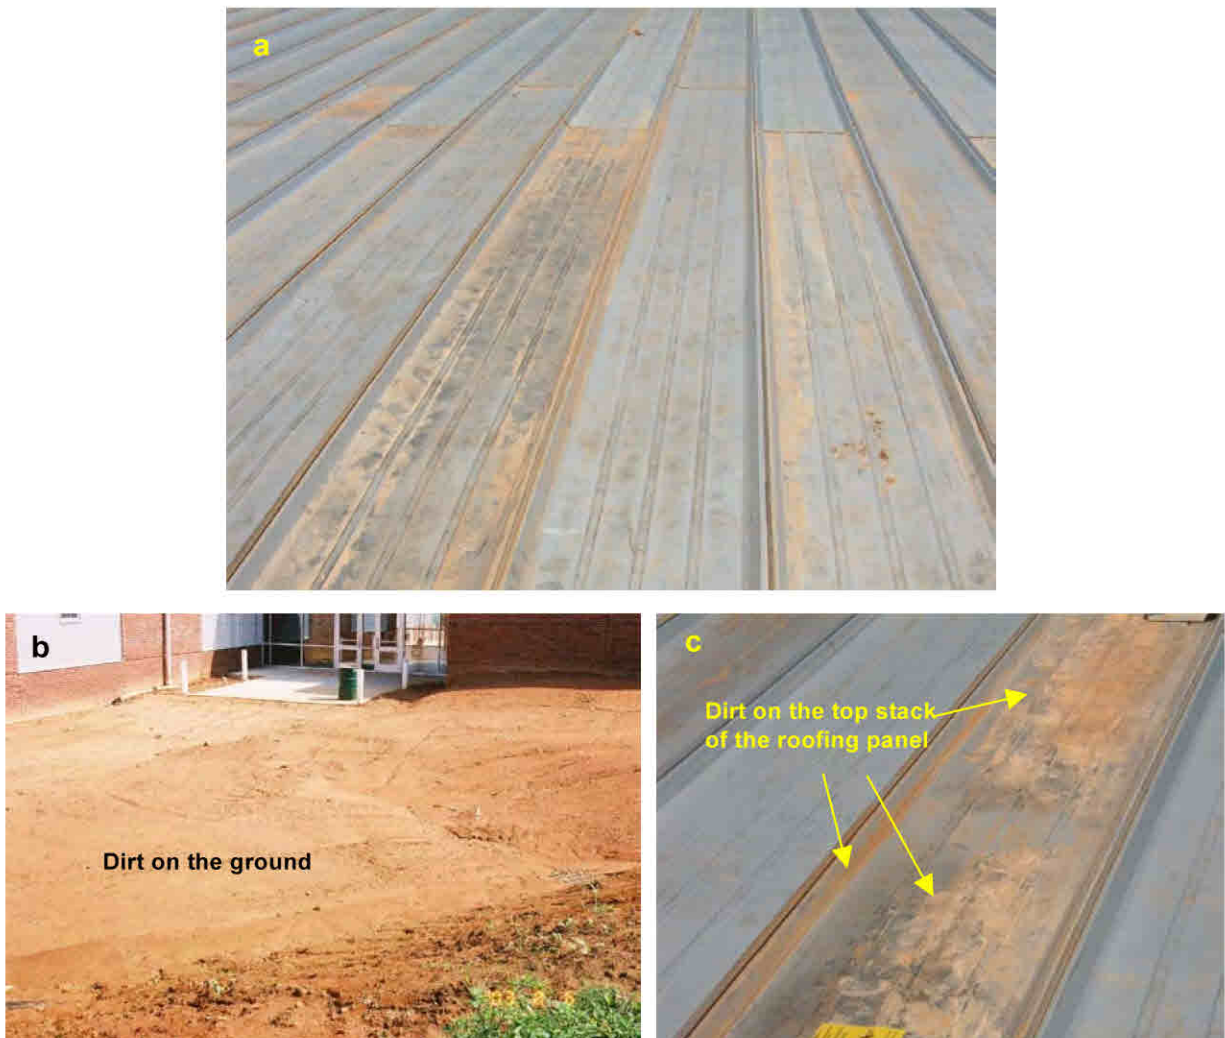
Staining and an inconsistent appearance of bare GALVALUME^{®1} Coated Sheet Steel roofs can be caused by dirt being introduced by either foot traffic and/or poor storage practices. The example in Figure 1 showed that the dirt on the roof (Figure 1a) matched the dirt on the ground (Figures 1b). The dirt was concentrated on the roofing panels on the top of the stack (Figure 1c) and transferred to the other panels by construction workers walking on the roof. If the dirt is not cleaned immediately after installation, it will cause staining and an inconsistent appearance to the roof, and possibly cause premature corrosion by trapping the moisture on the roof. Therefore, dirt and other debris should be cleaned immediately after installation.

Figure 1. Photographs of stains and inconsistent appearance of a bare GALVALUME[®] roof (a), dirt on the ground at a building site (b), and dirt concentrated on the roofing panels on the top of the stack (c).

The best way to avoid staining of panels is to maintain proper storage and handling practices during the entire construction process to avoid dirt getting on the panels in the first place. Annual washing of the building is recommended to maintain the overall appearance of the building. The useful life of the roof will also be extended by removing dirt and other moisture trapping debris, which can cause premature corrosion.

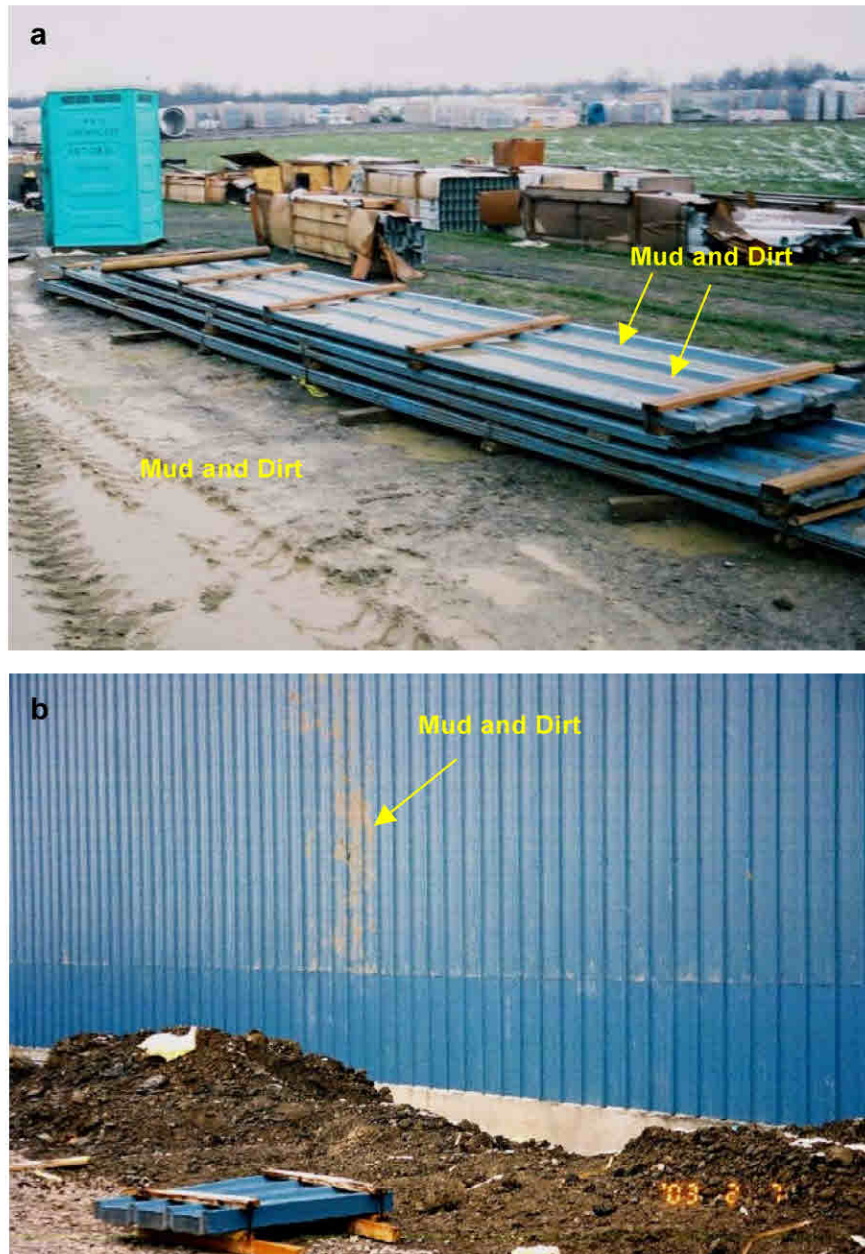
Similar dirt issues can also occur on prepainted panels. Figure 2 shows dirt and mud on the job site was transferred onto the surface of the prepainted GALVALUME® sidings before installation (Figure 2a), and the mud remained on the panels after installation causing appearance issues (Figure 2b). Dirt also concentrated on the top panel of the stack. The best way to avoid this situation is to maintain proper storage and handling practices during the entire construction process to avoid the dirt and mud getting on the panels in the first place. Dirt and mud should be cleaned immediately after installation.

Figure 2. Photographs of mud and dirt on the prepainted GALVALUME® siding panels (a) before and (b) after the installation.

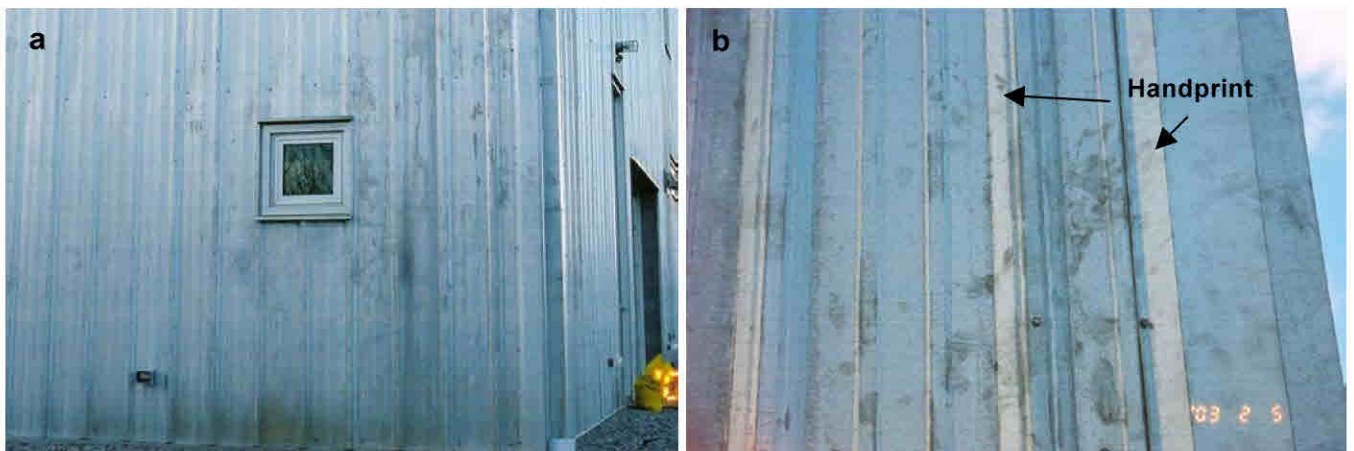
Figure 3. Photographs of handprints and smudge marks on bare GALVALUME® siding (a), and close-up view (b).

Instead of bare GALVALUME® Coated Sheet Steel, ACRYLUME®² Coated Sheet Steel can be used, which provides better hand, footprint and smudge mark resistance. ACRYLUME® Coated Sheet Steel has a very thin clear acrylic coating over GALVALUME® Coated Sheet Steel. The acrylic coating also provides better protection during storage.

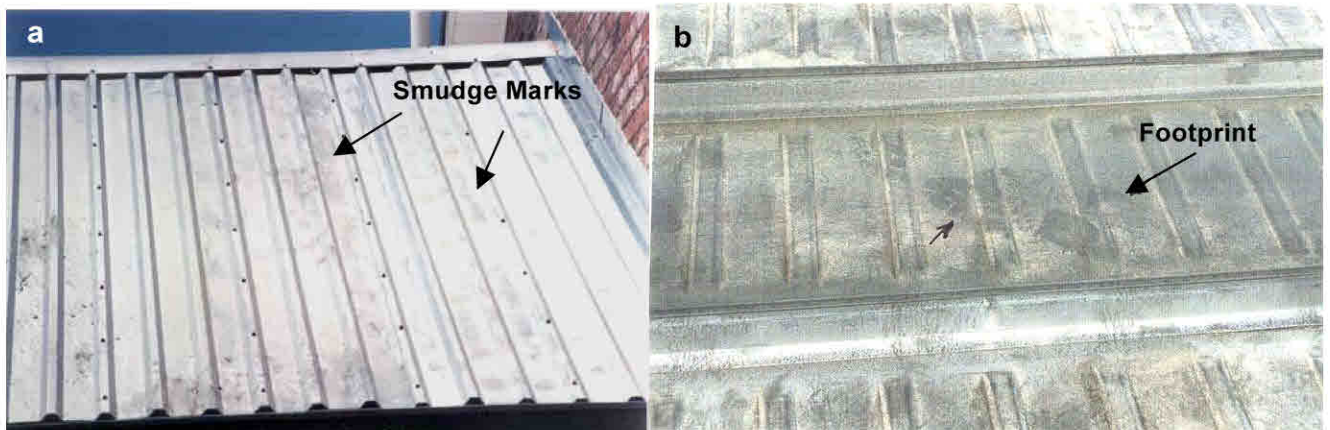
Figure 4. Photographs of smudge marks (a) and footprints (b) on bare GALVALUME® roofs.

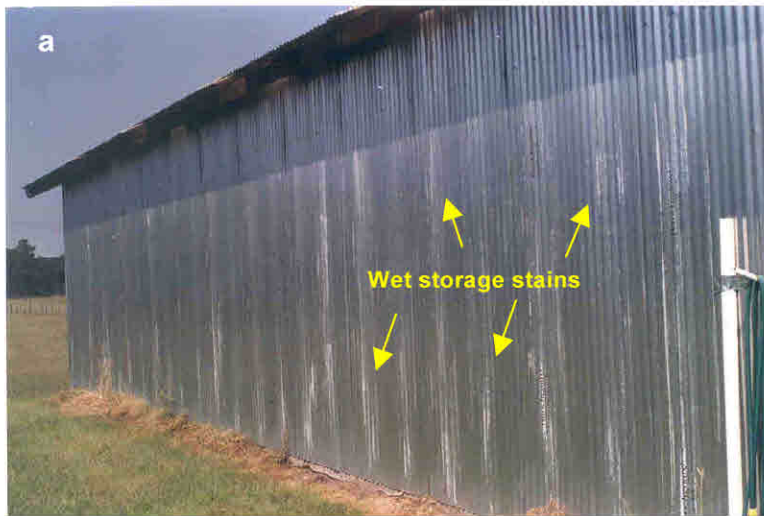
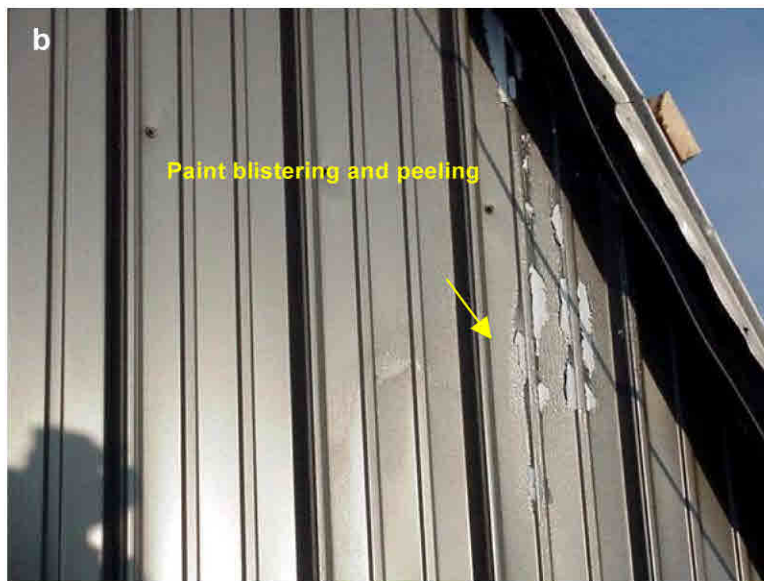
Figure 5a shows white rust and storage stain, on the bare galvanized steel. Wet storage problems are not limited to bare materials. Prepainted products are also susceptible to wet storage issues, which occur when the panels are in bundle form and exposed to moisture, such as the siding panels shown in Figure 5b. The difference with painted panels is that the corrosion starts underneath the painted surface and first appears in the form of blisters or a rough surface, which eventually progress to the point at which the paint peels from the galvanized steel panels. For more information, see National Coil Coater's Association Technical Bulletins at <http://www.coilcoating.org>.

Wet storage stain can be easily identified. Typically, there is no orientation to the staining pattern, but the white rust or the stain patterns should be on both sides of the panel. If the panels are still stacked in the bundle, the pattern should be in a mirror image on the bottom side of the panel to the top side of another panel that it was in contact with.

Figure 5. Photographs of wet storage stains on bare galvanized steel siding (a), and wet storage causing paint blistering and peeling on prepainted galvanized steel siding (b).

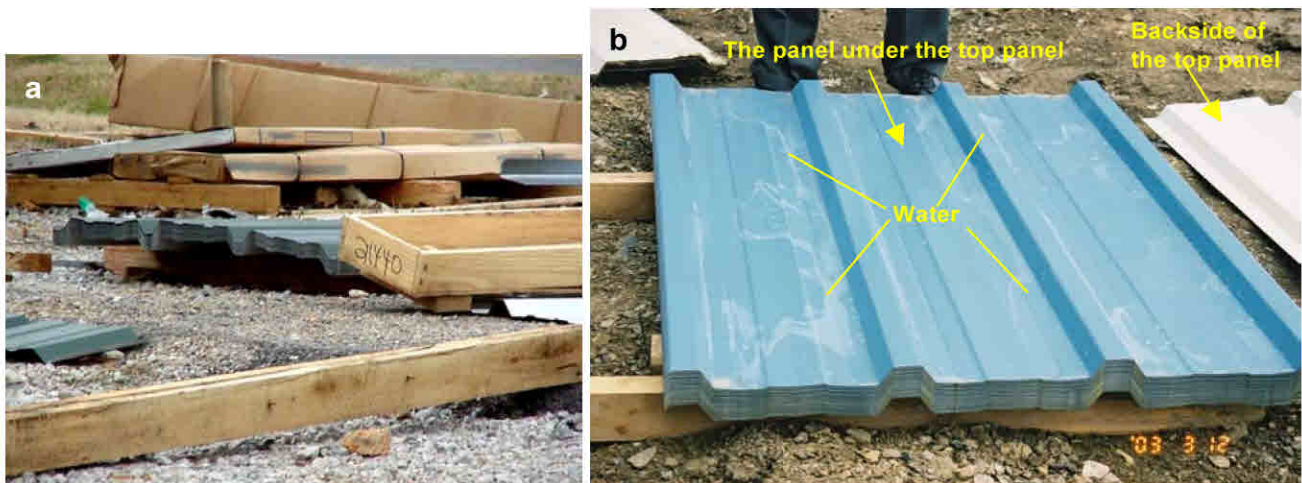
Wet storage conditions are frequently found on job sites where panel bundles are improperly stacked (Figure 6a), or are laid flat on the ground, without protection (Figure 6b). Water can penetrate between the panels by condensation, or capillary action, creating wet storage conditions, which cause paint blistering and substrate corrosion on the prepainted panels, while causing storage stain on the bare hot dip galvanized or GALVALUME® Coated Sheet Steel. Therefore, panels and accessories should not be stored in wet conditions. Care should also be taken to avoid handling damage on the job site. The panel storage condition shown in Figure 6a could potentially create a wet storage condition and cause premature corrosion. It could also cause damage to the panel before installation.

Figure 6. Photographs of panel bundles improperly stacked at the job site (a), and water on the surface of a panel that was in the bundle under the top panel (b).

Bundles should be positioned with one end slightly elevated to permit runoff of moisture from the top of the bundle or from between nested panels. Water-resistant paper will not necessarily provide long-term resistance to moisture penetration from puddled water on top of the bundle. A waterproof cover should be placed over the bundles while allowing for air circulation under the cover (see Figure 7). More information can be found in U. S. Steel Technical Bulletins at <http://www.ussteel.com> or in the National Coil Coater's Association Technical Bulletins at <http://www.coilcoating.org>.

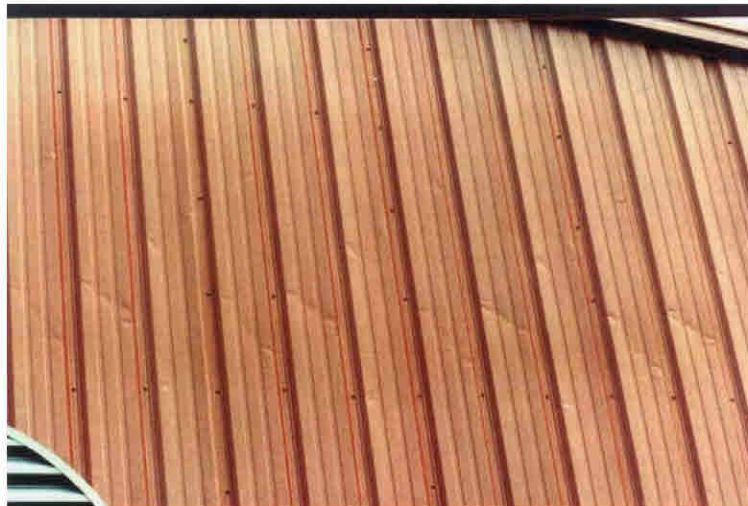
Figure 8 is an example of transit and handling damage. The pattern of the damage is typical of handling issues while panels are still in bundle form. Regardless of whether the damage was caused by blocking, forklifting or by some other external force, it usually exhibits a repetitive pattern. Nevertheless, the damaged panels should have never been installed. Figure 9 shows other examples. Mishandling of the panels caused paint abrasion damage at the radii of the major ribs in the up-down direction (Figure 9a), which could result in premature corrosion. The scratches on the surface of painted panel caused premature corrosion in the damaged area (Figure 9b).

Figure 8. Photograph of damaged panels on the building's sidewall.

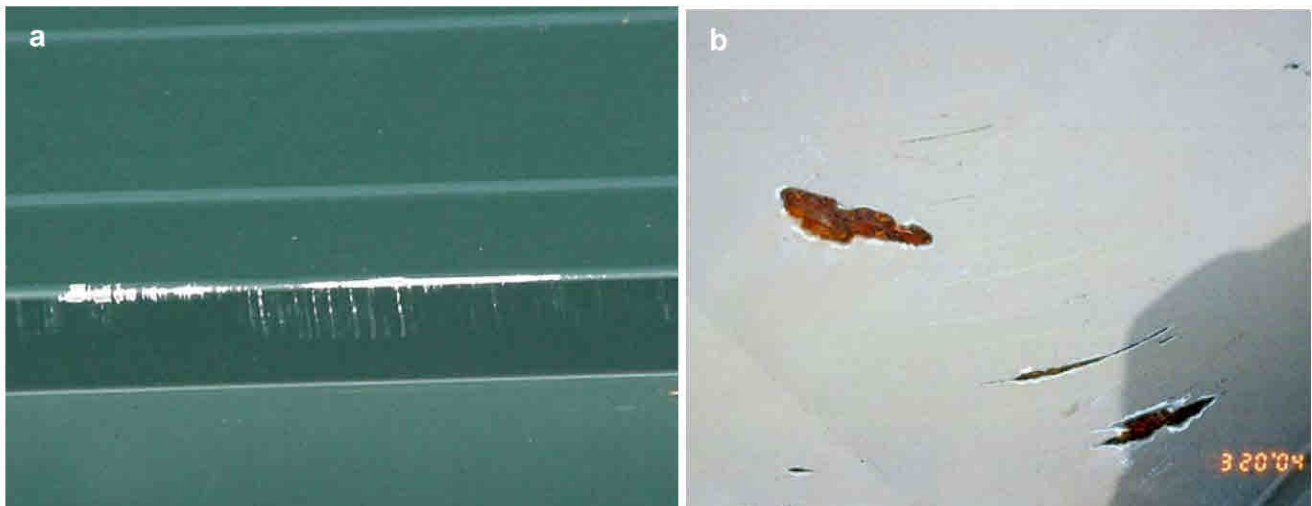
Figure 9. Photographs of paint abrasion damage on the major rib of the panel (a), and scratches on the surface of a painted panel resulted in premature corrosion (b).

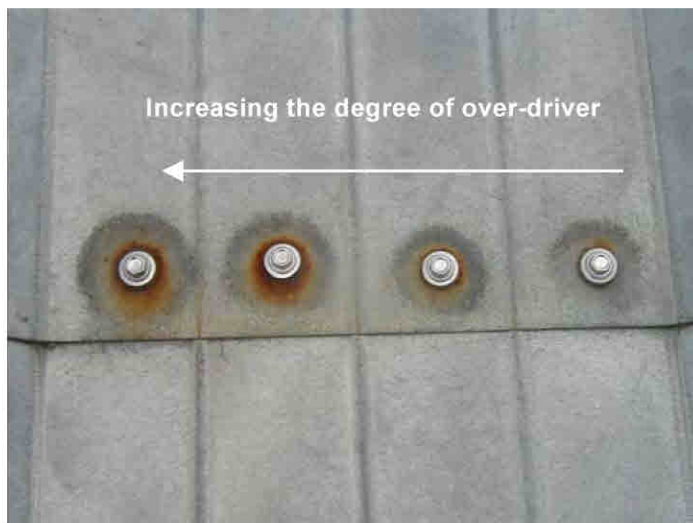
Figure 11. Photograph of the over-driven fasteners. The corroded area around the fastener increased with increasing depth of depression.

Fasteners should be installed properly to avoid being over-driven, under-driven or driven at an angle. Figure 10³ is a schematic example of the proper and improper installation of fasteners. Properly seated and installed fasteners should be watertight and not allow water to leak or allow water to collect around them. Over-driven fasteners may cause depressions around the fasteners, which can collect water and accelerate corrosion. Therefore, impact-type tools should not be used. Figure 11 is an example of over-driven fasteners. The GALVALUME[®] material around the fasteners was corroded due to water ponding in the depression. The corroded area around the fastener increased with increasing the depth of the depression. Under-driven fasteners or fasteners that “back out” over time can allow water to leak at fasteners allowing water to saturate insulation causing inside-out corrosion (Figure 12⁴). Driving tools with depth-sensing nose-pieces and suitable speeds can help to avoid these problems.

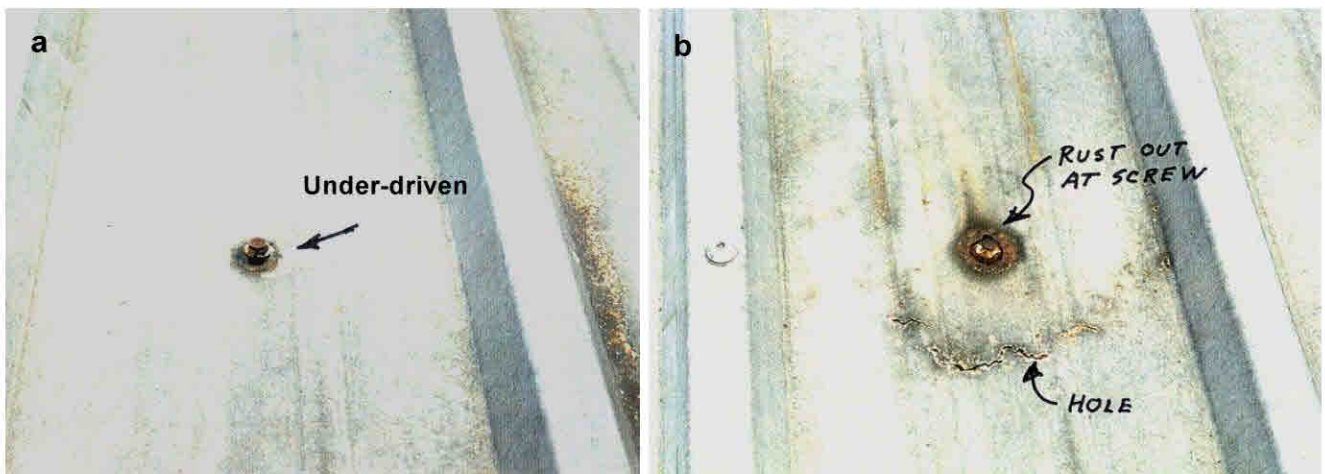
Figure 12. Photographs of under-driven fasteners with water leaking at fastener to cause corrosion at the fastener (a and b), and caused inside-out corrosion due to water saturation of the insulation (b).

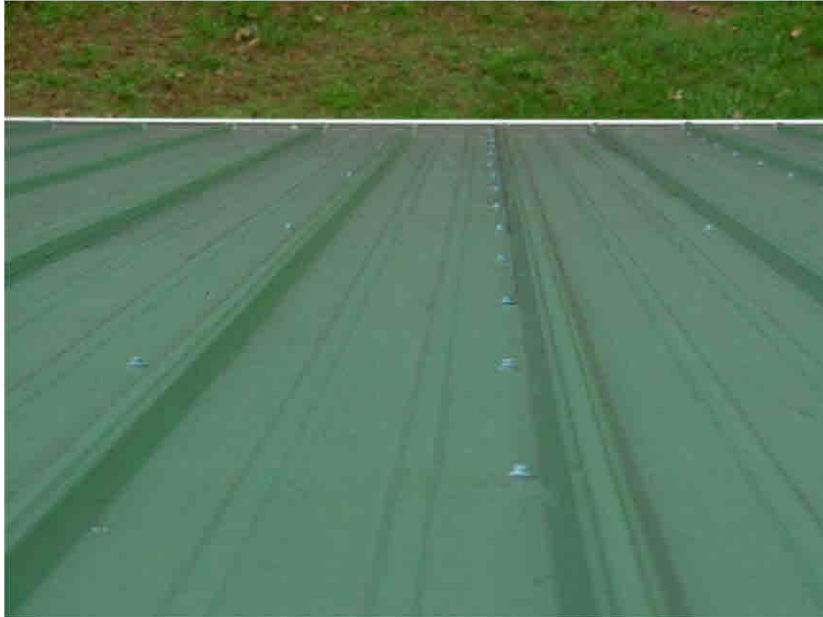
One of the distinctive features of a high slope metal roof is its unique appearance. The choice of the fasteners should match the color and the performance of the roofing panels. Otherwise, the appearance or even the performance of the roof may be adversely affected. Figure 13 shows a green colored prepainted galvanized steel roof with discoloration of the screws. Improper fasteners were used, which resulted in the red rusting of the screws and the discolored appearance of the roof. This problem would not have occurred, if the correct fasteners had been used (Figure 14).

Figure 13. Photograph of the prepainted galvanized steel roof with non-matching screws.

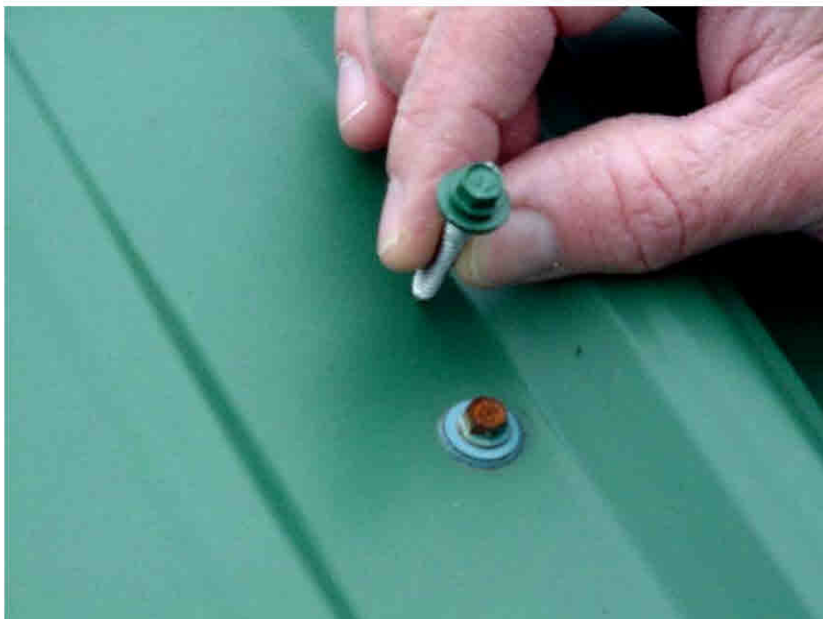
Figure 14. A close view of a non-matching screw with red rust and the correct screw, held in the hand, which should have been used for this application.

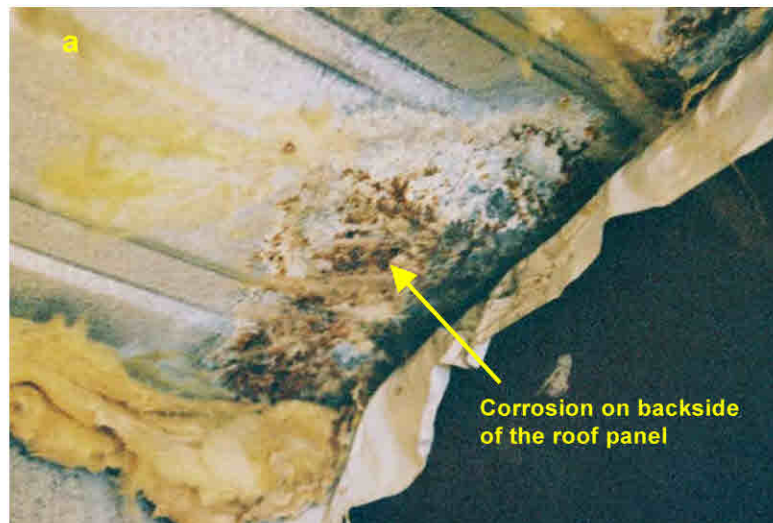
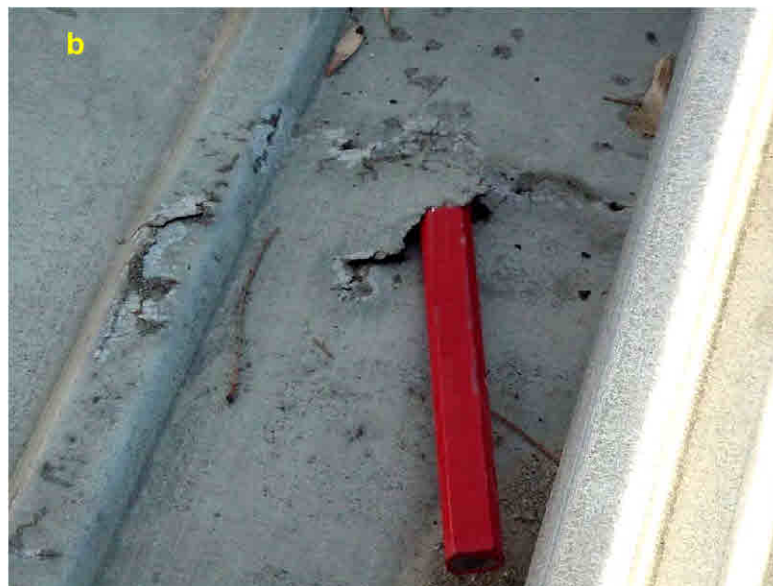
Insulation provides resistance to heat transfer and protects against condensation forming on cold surfaces inside the building or within the wall/roof system cavities. The insulation should have a vapor retarder face on the “warm” side of the insulation. For most buildings, the vapor retarder is on the inside surfaces facing the building interior. The thickness of the insulation must be designed to maintain the temperature of the vapor retarder above the interior dew point under the worst expected outside temperatures. All perimeter conditions and seams must be adequately sealed to avoid moisture penetration of the vapor barrier and provide a continuous membrane to resist the passage of water vapor. Failure to do so could cause wet insulation, which could cause corrosion on the underside of the roof panels (Figure 15a). This corrosion may lead to perforation corrosion from the inside of the roof panels (Figure 15b).

Figure 15. Photographs of roof panel corrosion due to wet insulation. The corrosion of the GALVALUME® panels was observed on the bottom side of the panels after the insulation was removed (a). Perforation corrosion was observed on the top side of the roof panels (b).

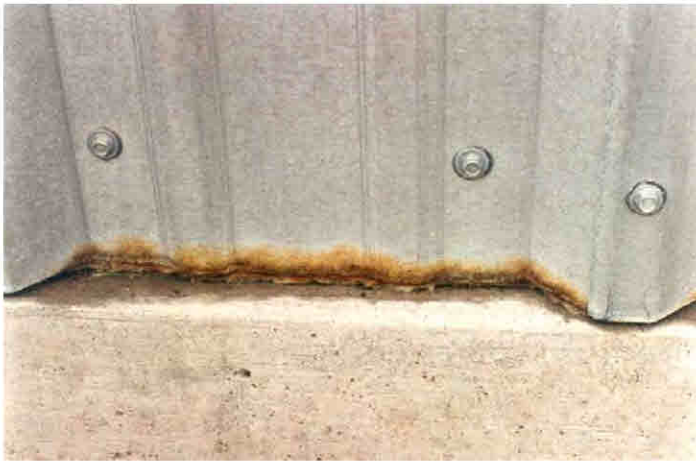
Figure 16 is a classic example of “insulation wicking” causing premature failure of the coated panel. The insulation soaked up the available moisture creating an environment that was always wet causing accelerated corrosion. The contractor should be fully aware that insulation and other building materials that can soak up moisture should not be exposed to the exterior of the building. One solution is to install the insulation at least one inch above the bottom edge of the panels and to fold the insulation face around the bottom edge of the fiberglass (see Figure 17).

Figure 16. Premature corrosion at the bottom edges of the GALVALUME® panel caused by insulation wicking.

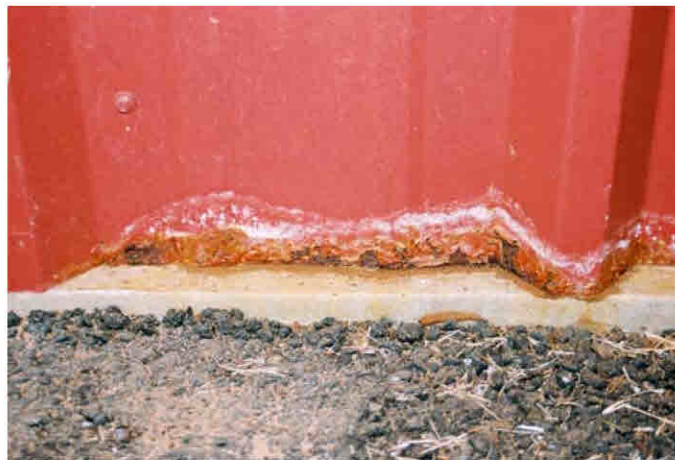
For bare and painted GALVALUME® products, direct contact with cement foundations is not recommended. Accelerated corrosion can occur due to the lime contained in the cement. An example of which with prepainted GALVALUME® siding is shown in Figure 18. Additionally, close proximity to a cement producing facility is not recommended as airborne cement is similarly corrosive to galvanized and GALVALUME® Coated Sheet Steels.

Figure 18. Premature corrosion at the bottom edges of the prepainted GALVALUME® panel caused by direct contact with the concrete foundation.

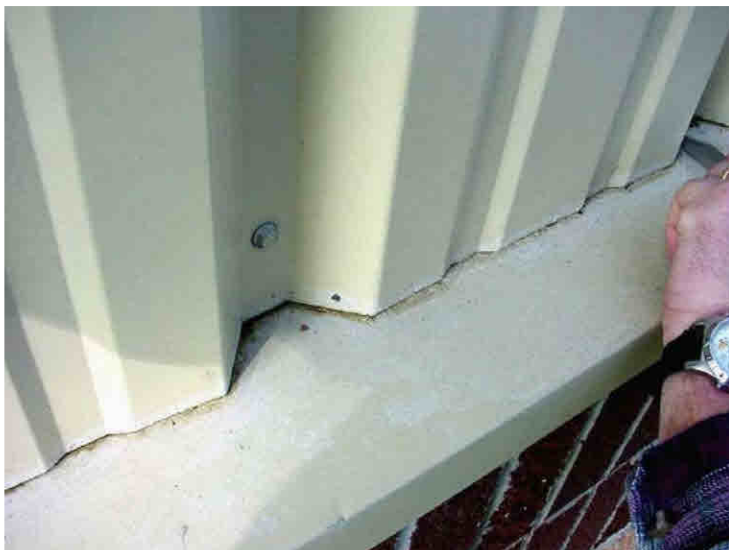
Figure 21 shows premature corrosion on the bottom edge of prepainted GALVALUME® siding where paint blisters and noticeable white residue stain could be observed along the panel edge and on the concrete surface, one year after the installation. This is a typical example of siding installed without flashing on a flat concrete base that does not allow water drainage.

Figure 21. Photograph of premature corrosion on the bottom edge of the siding.

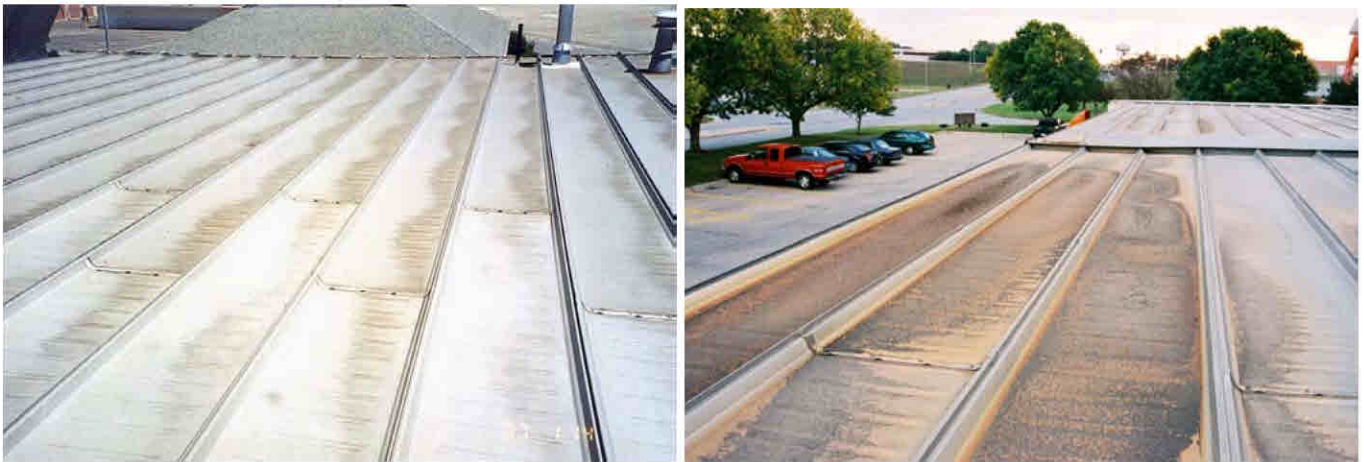
Figure 22. Photographs of water ponding on a GALVALUME® roofs due to improper slope of the roof.

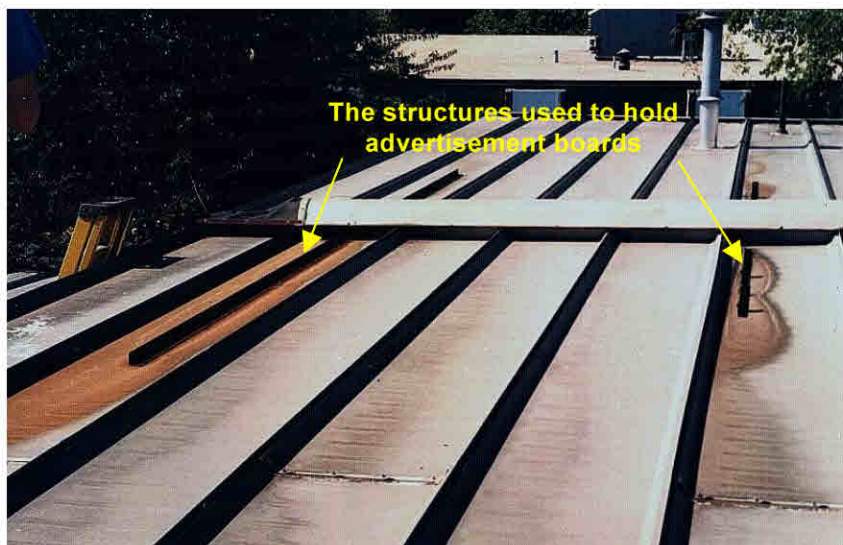
Water ponding may also occur in areas where localized deformation of the roof panels has occurred. The corrosion of the GALVALUME® roof panel in Figure 23 was caused by water ponding at the low spots caused by the weight of advertisement boards that had been positioned on top of the roof.

Figure 23. Photograph of a GALVALUME® roof after 21 years service. The localized corrosion was caused by water ponding at the low spots where the advertisement boards were set on top of the roof.

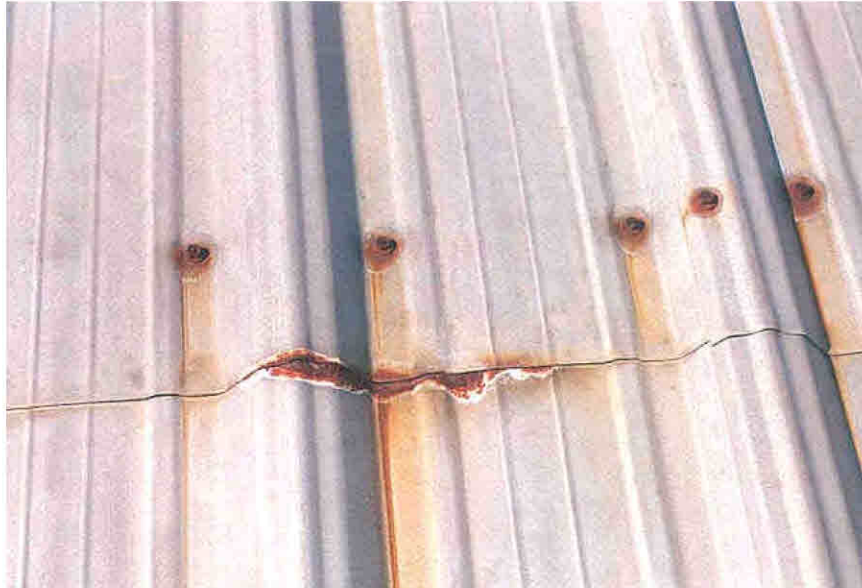
Sealant should be applied at panel end laps to prevent moisture from entering the panel lap joints and causing premature corrosion. Figure 24⁵ shows the crevice corrosion caused by poor end lap sealing on a GALVALUME® roof. Figure 25 shows the paint blistering on a prepainted GALVALUME® roof caused by poor end lap sealing.

Figure 24. Crevice corrosion caused by poor end lap sealing on a GALVALUME® roof.

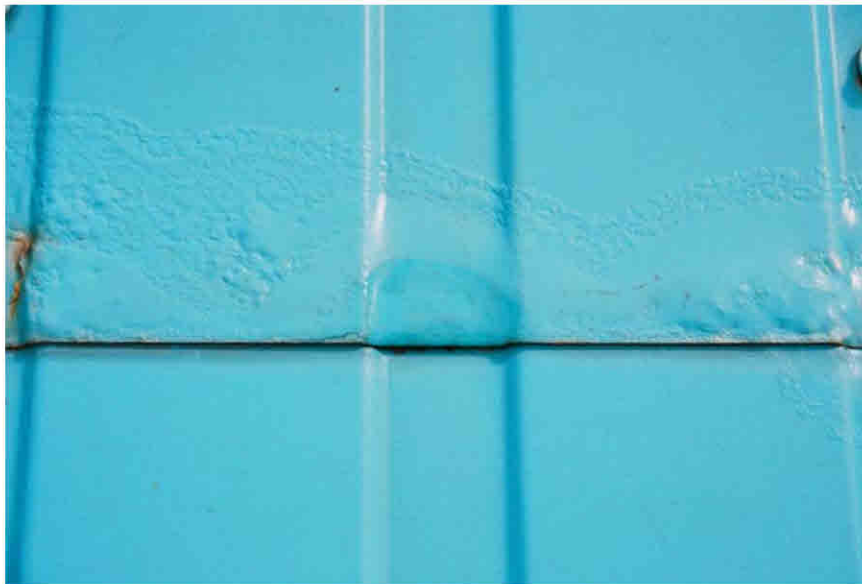
Figure 25. Paint blistering on a prepainted GALVALUME® roof caused by poor end lap sealing.

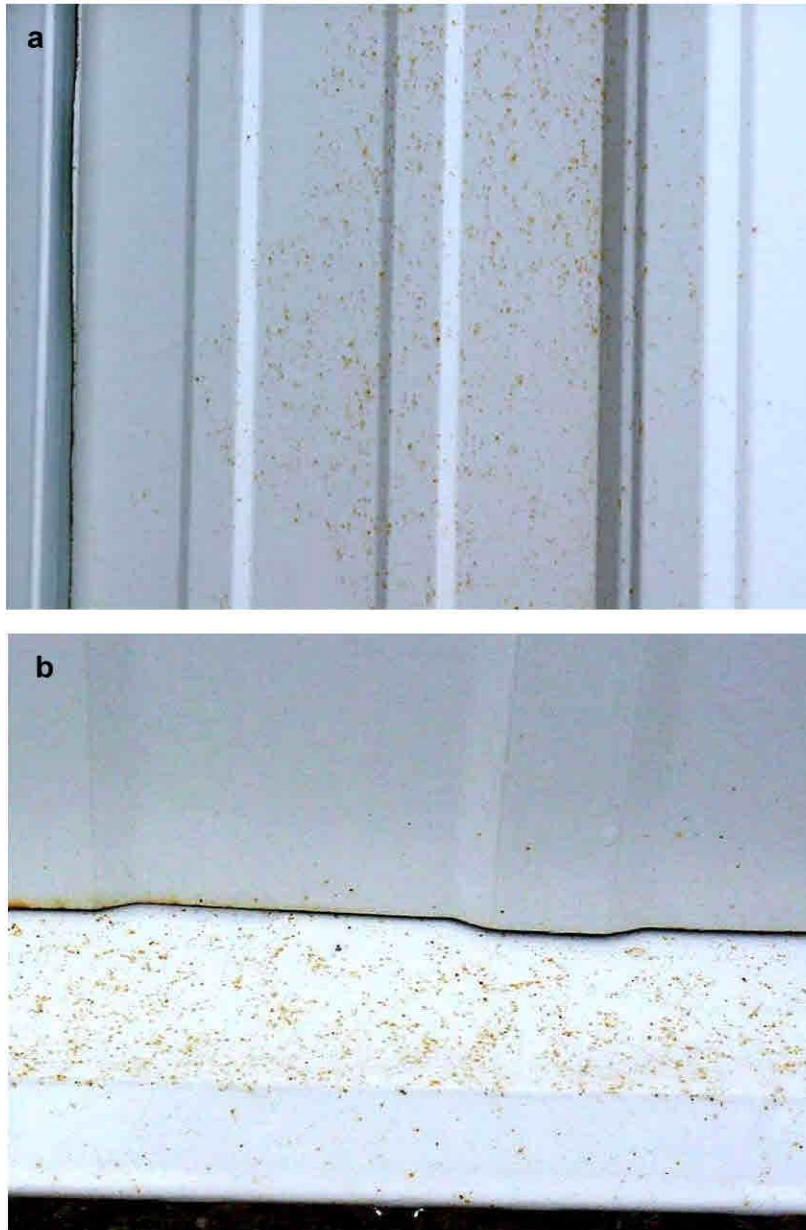
Metal debris from sawing, drilling and other construction processes should be removed during installation. Otherwise, the metal filings will red rust on the surfaces where they were deposited. Red rust of the metal filings may cause stain or discoloration on the surface of the panel whether it is bare or painted and cause appearance issues. Contractors should be cautioned about the importance of removing any debris generated during installation. Cutting and drilling should be done on the backside of the panels in order to avoid damaging the exposed surface with hot metallic particles. Figure 26 shows red rusted metal filings and the stains on a prepainted siding panel and on the concrete base at the bottom of the siding.

Figure 26. Photographs of red rusted metal filings and the stains on a prepainted siding panel (a) and on the concrete base at the bottom of the siding (b).

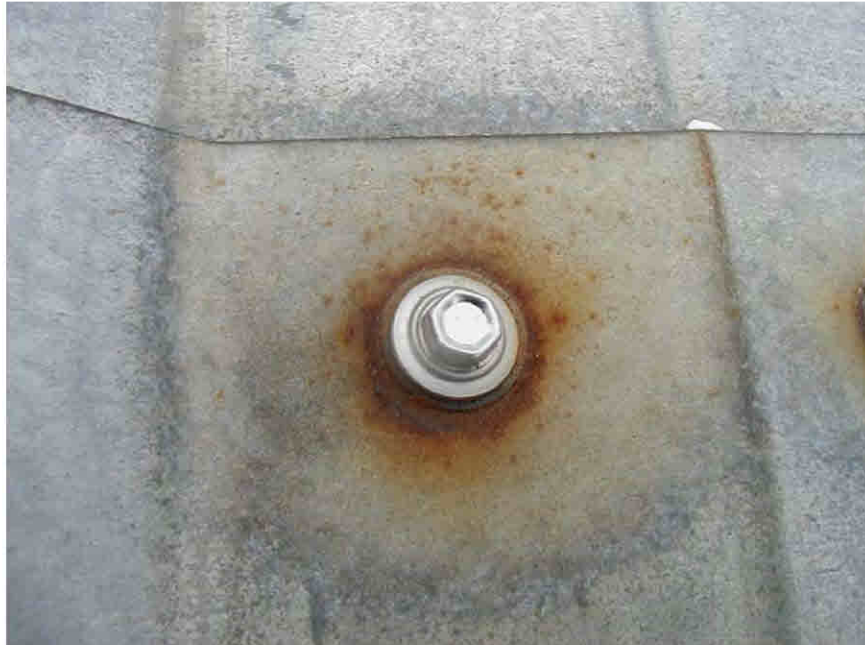
Figure 27 shows the red rusted metal filings on the surface of a bare GALVALUME® roof panel around a screw due to failure to remove the metal fines from drilling. Figure 28 shows another example of not removing metal filings after drilling screw holes on a prepainted GALVALUME® roof panel. Care must be taken to minimize the contact of hot metal filings from self-drilling or self-tapping screws with the coated panel surface. Any metal filings remaining on the panel surface must be removed at the end of each workday. Otherwise, those fine metal particles will corrode and result in rust staining on the panel surface.

Figure 27. Photograph of red rusted metal filings on the surface of bare GALVALUME® roof panel around a screw.

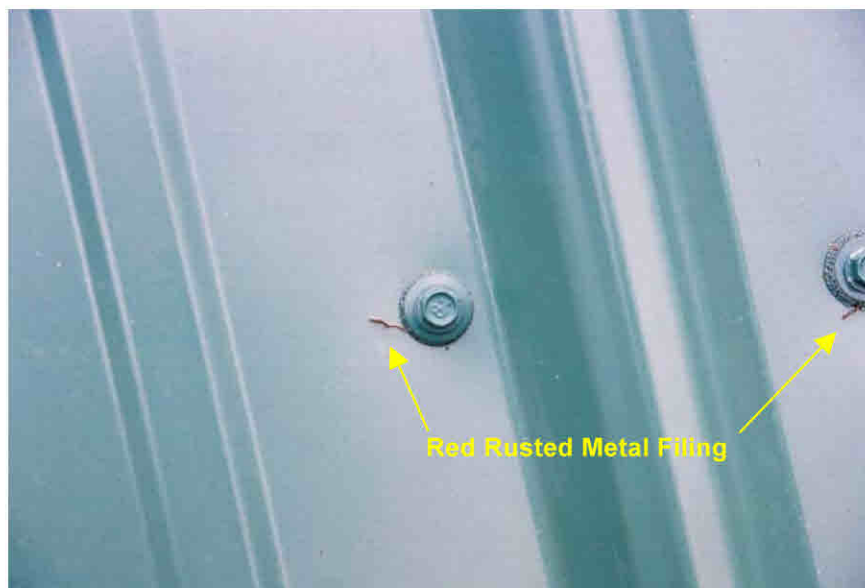
Figure 28. Photograph of red rusted metal filings from the screws on a prepainted GALVALUME® roof panel.

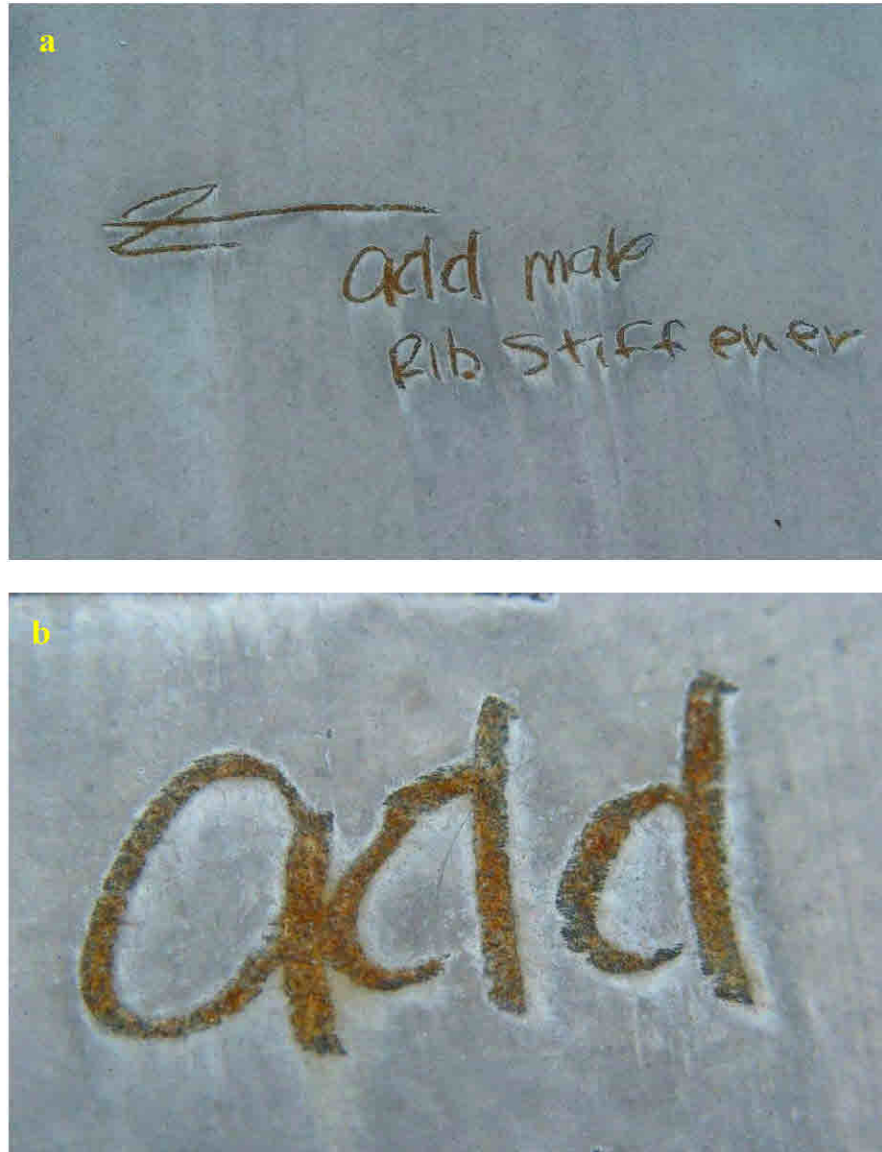
Pencil is made of graphite. When a pencil is used to write on galvanized steel it leaves graphite powder on the surface. Figure 29 is an example of pencil mark corrosion on galvanized steel sheet. Pencil mark corrosion is a form of galvanic corrosion. Because graphite is electrochemically very noble, 3 to 4 volts more noble than the zinc, a strong galvanic cell is created and the zinc on or adjacent to the pencil mark rapidly corrodes. The open circuit potential of graphite is cathodic to all metals and alloys in most aqueous environments. One should never write on galvanized steel with a pencil.

Figure 29. Photographs of pencil mark corrosion on galvanized steel sheet (a), and a magnified view of the mark (b).

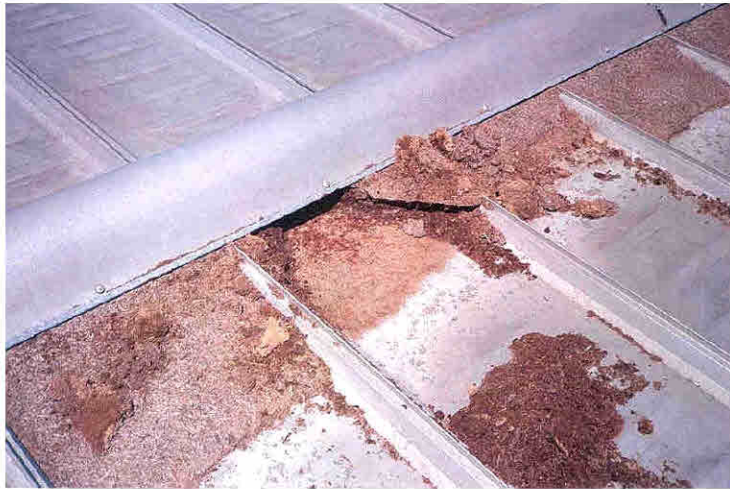
Figure 30. The wood chip debris piled near the ridge cap caused heavy corrosion of the roof panel due to water being retained by the debris.

Debris should be removed from the metal roof during or following installation and through regular roof maintenance because debris can cause staining and premature corrosion. Figure 30⁶ shows wood chip debris piled near the ridge cap that caused heavy corrosion of roof panel due to water being retained by the debris. Figure 31⁶ shows that the corrosion occurred under the treated lumber because chemicals, particularly copper compounds, leached from the wood accelerating the corrosion. Figure 32 is another example; a piece of metal tube left on the roof caused staining and corrosion of the roof panel.

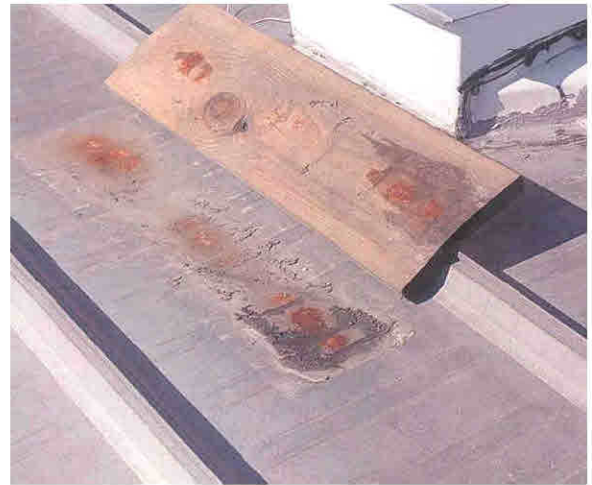
Figure 31. Corrosion occurred under the treated lumber because chemicals, particularly copper compounds, leached from the wood accelerating the corrosion.

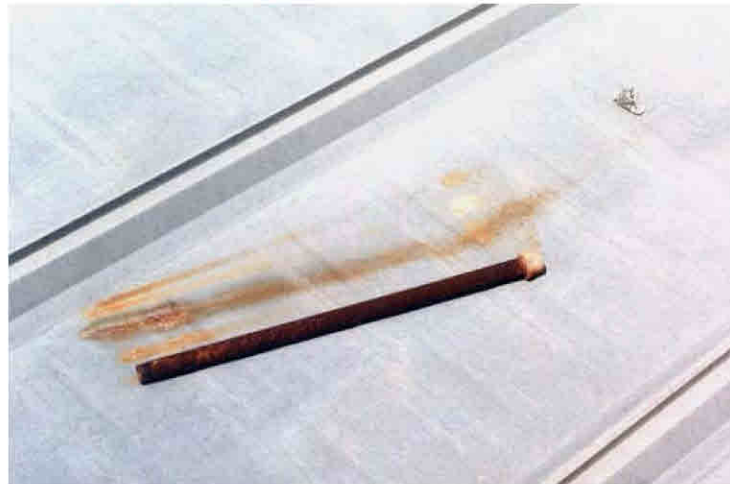
Figure 32. A piece of metal tube left on the roof caused staining and corrosion of the roof panel.

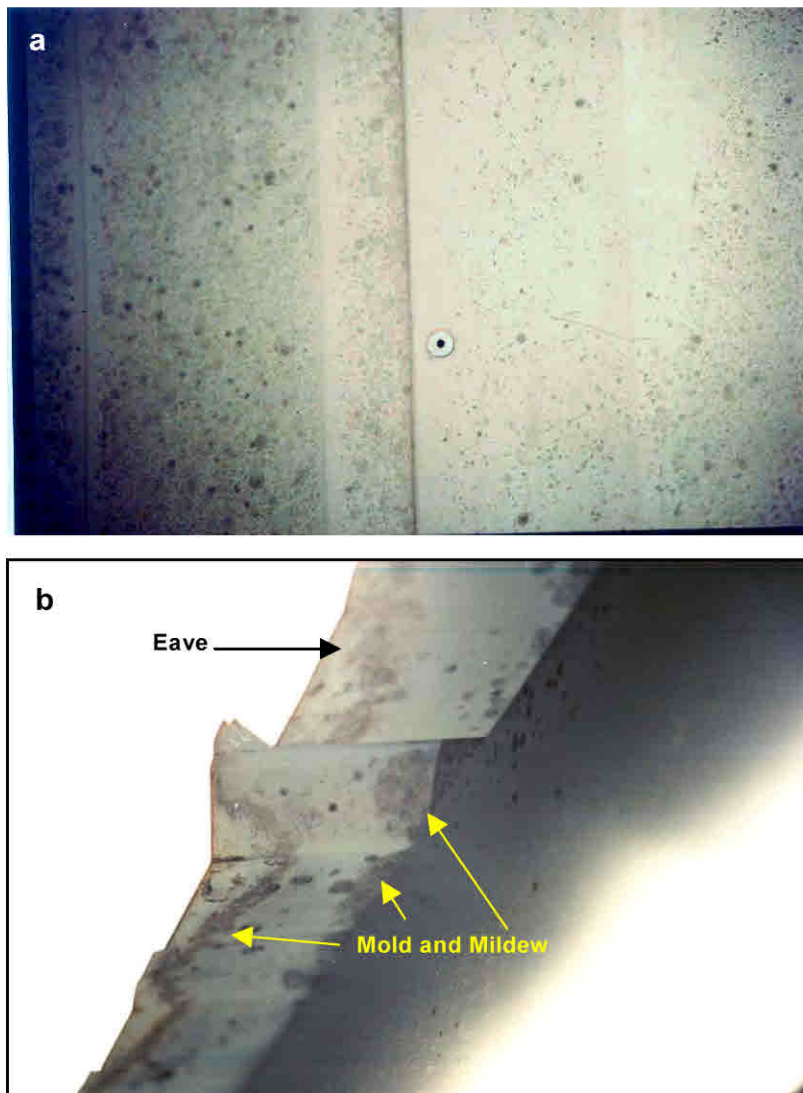
The photographs in Figure 33 show a green/brown appearance of mold or mildew on painted side wall panels and on the under side of the eave, which could cause staining on the surface. This is considered a maintenance issue. Proper ventilation and periodic cleaning should reduce the impact of mold and mildew. Remove mildew by wiping or by using a power spray. Then wash the area with an antiseptic cleaner such as bleach. Rinse the area thoroughly.

Figure 33. Mold or mildew buildup on painted side wall panel (a) and on the under side of the eave (b) where the building was surrounded by a woody area and constantly exposed to a high humidity environment.
