STAINING OF BUILDING PANELS FROM STEEL DEBRIS

TBP 2005.1

Job Site Imperfections

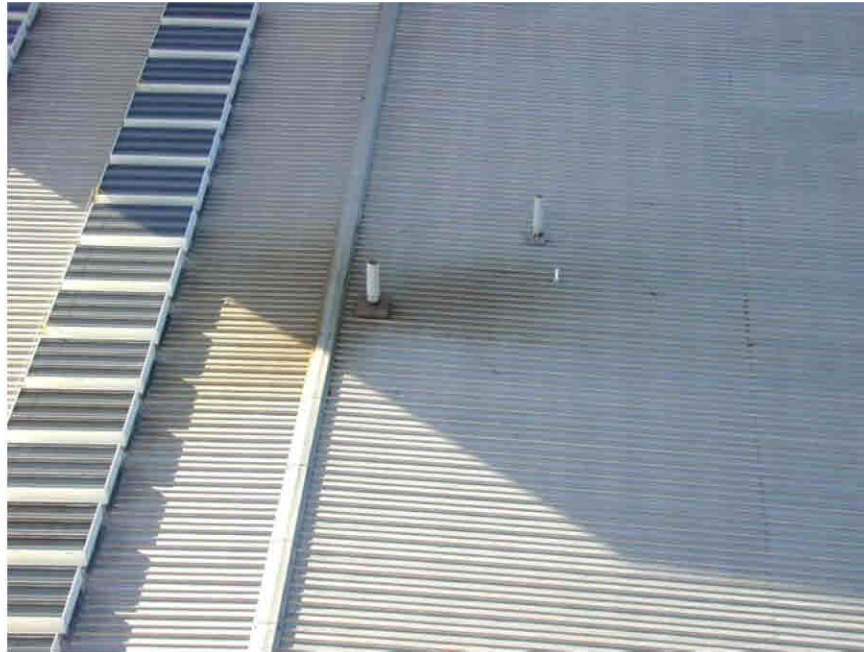
Exhausts discharged through roof stacks can sometimes create corrosive environments around them. The roof panels should be inspected periodically. The panels around exhausts can be coated with recommended maintenance paints, if it is necessary. Figure 34 shows a bare GALVALUME® roof corroded around the vent from a laboratory where acid was constantly used. Figure 35⁷ shows that the GALVALUME® roof around the roof stacks was corroded after 20 years due to the exhaust from a space heater.

Figure 34. The bare GALVALUME® roof was corroded around the laboratory vent.

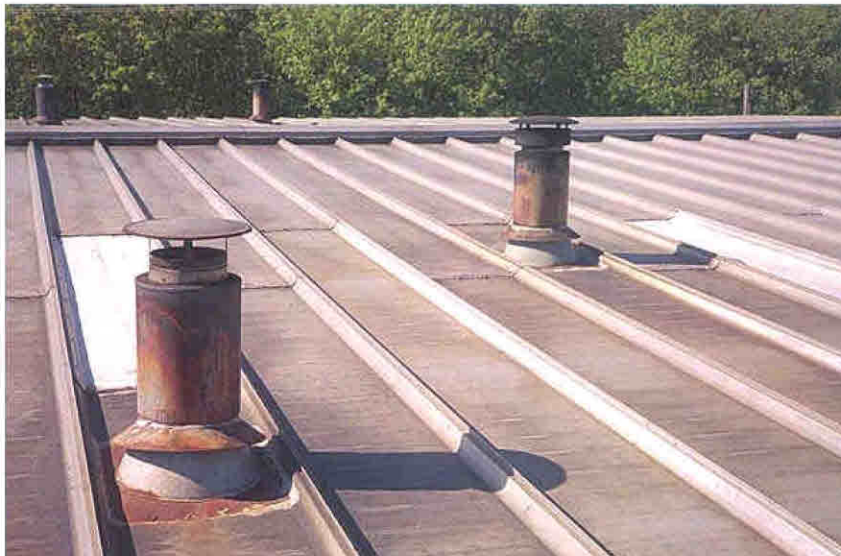
Figure 35. The GALVALUME® roof was corroded around the roof stacks.

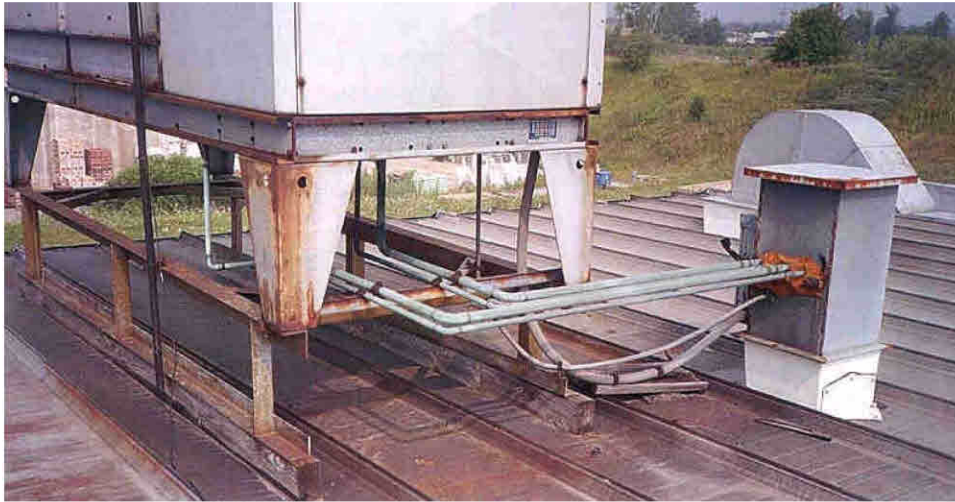
Galvanized and GALVALUME[®] panels should not be in contact with, or subject to, water runoff from copper, lead, or uncoated steel materials. Condensation water from air conditioning units typically contains dissolved copper, which should be discharged through a plastic pipe extended beyond the edge of the roof. The effect of the condensation water runoff from the copper piping on the GALVALUME[®] panels is significant in both outdoor and indoor situations, such as shown in Figure 36⁸ and in Figure 37.

Figure 36. GALVALUME[®] roof panel corrosion due to condensation water runoff from the copper pipes.

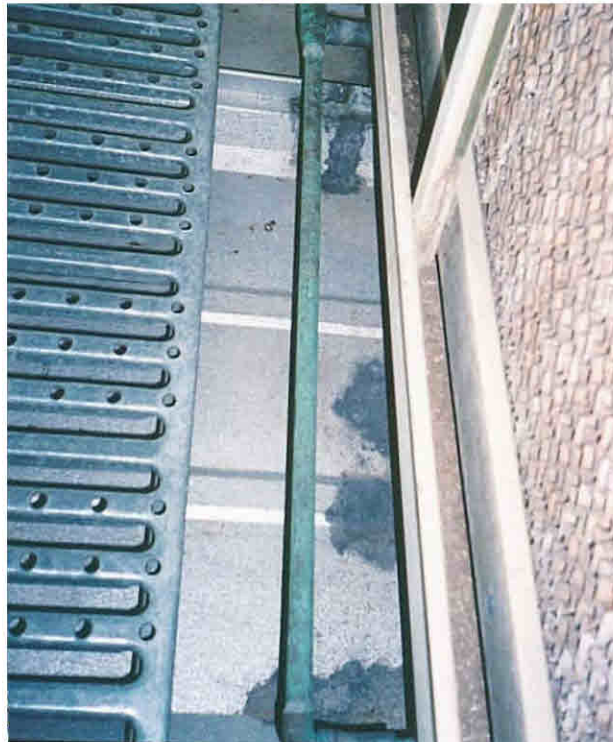
Figure 37. GALVALUME[®] panel corrosion due to condensation water runoff from the copper pipes.

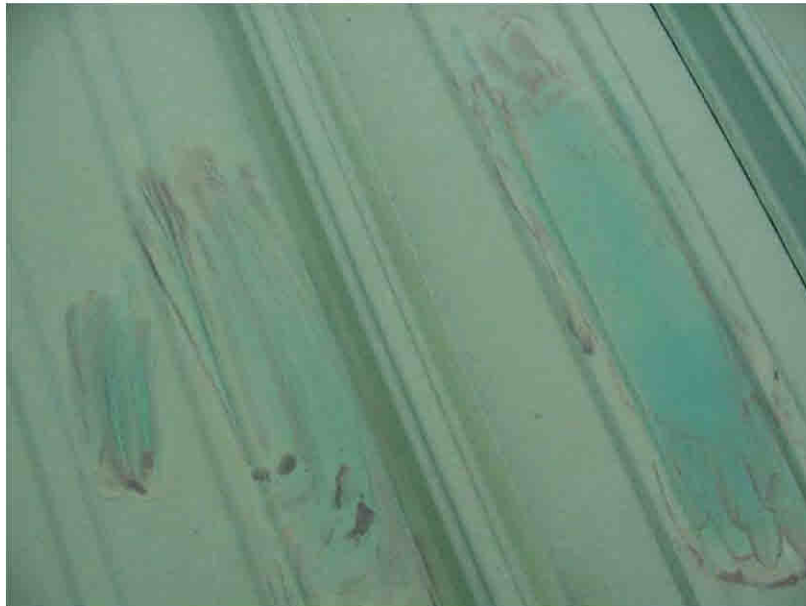
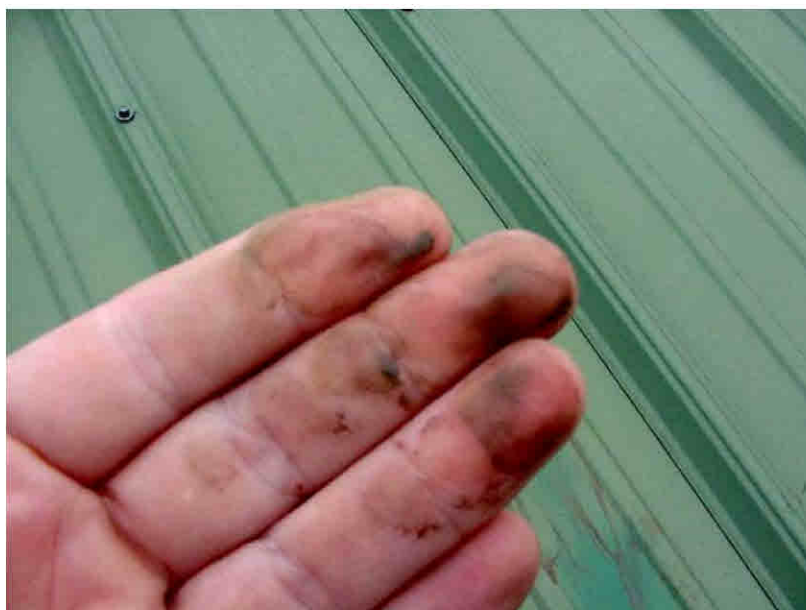
Two types of dirt accumulate on buildings: dry soil and greasy or organic residues. The dry dirt, by itself, washes off with rain or high-pressure water spray. Greasy residues do not wash off in rain and hold dry soil and chalk tightly to the surface. These residues originate from automobile exhaust, fireplaces, ventilation fan oil, pesticides, and various other common sources. This is the kind of dirt that requires cleaners for removal. Detergents, ammoniated cleaners and solvents are particularly effective in removing this greasy kind of dirt. Generally, lighter colors show dirt more than dark colors. However, dirt remaining on a darker roof can also cause discoloration, an example of which is shown in Figure 38. The bright color has been covered by dirt.

Figure 38. The prepainted GALVALUME® roof panel discoloration is due to dirt coverage.

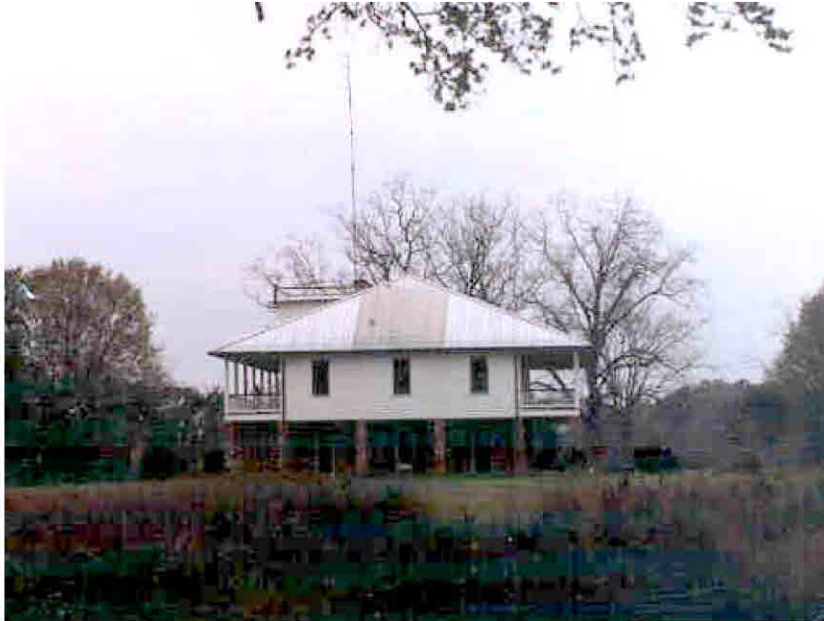
Figure 39. Differential darkening of bare GALVALUME® panels on a high slope roofing application.

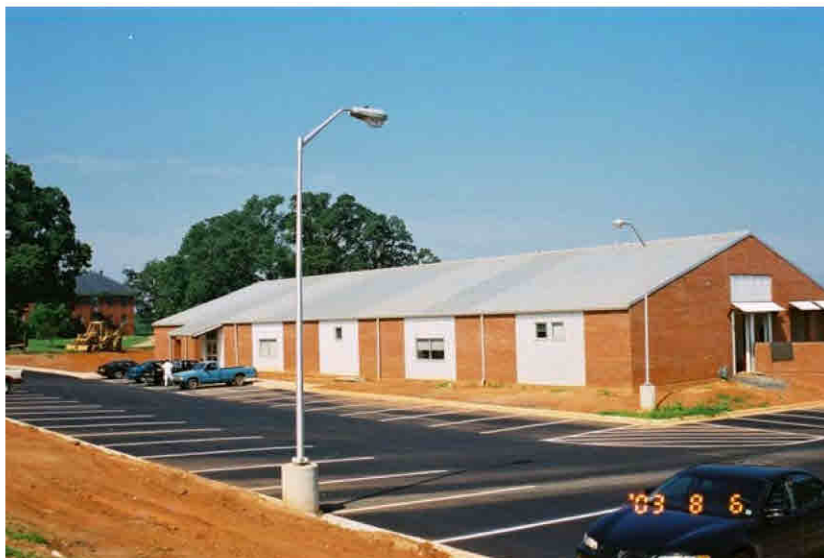
Figure 40. Differential darkening of ACRYLUME® panels on a high-slope roofing application.

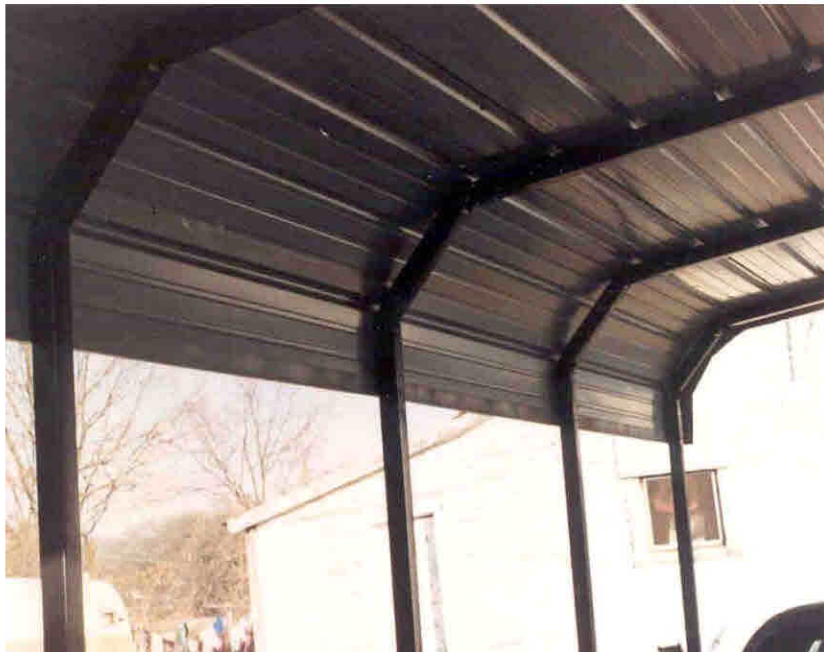
Figure 41. Improper roof profile design of a pole building with open sides does not allow rainwater to runoff along the curvature of the roof.

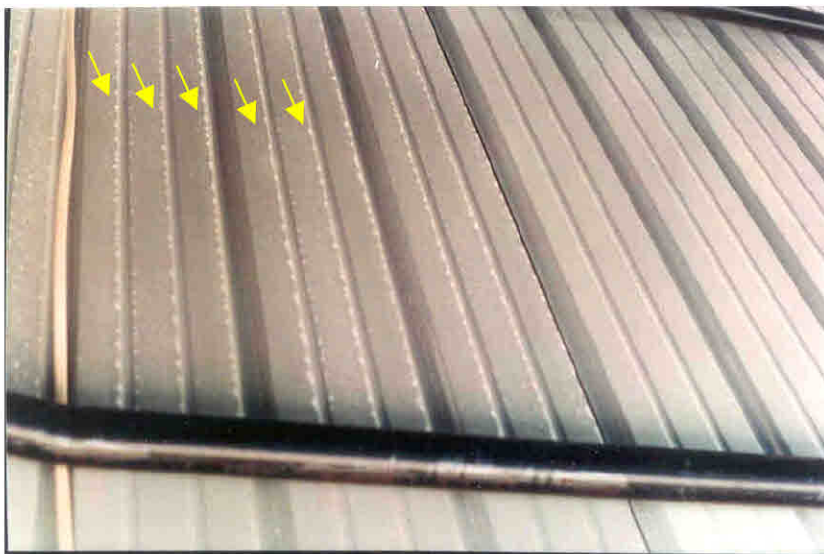
Figure 42. Photograph of the backside of the roofing panel shows condensation accumulating along the ribs of the panel as the arrows indicate.

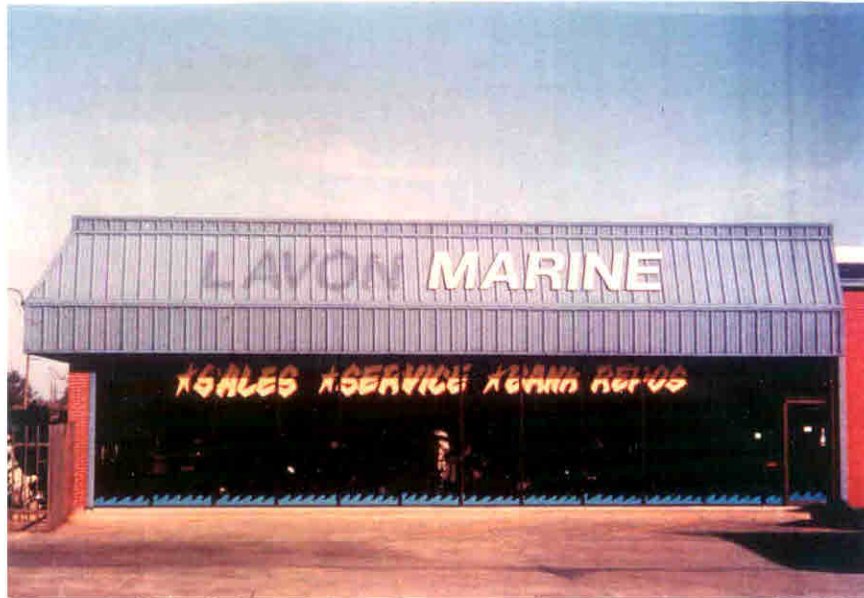
Figure 43. Color fading of the paint on prepainted panels due to UV light from the sun.

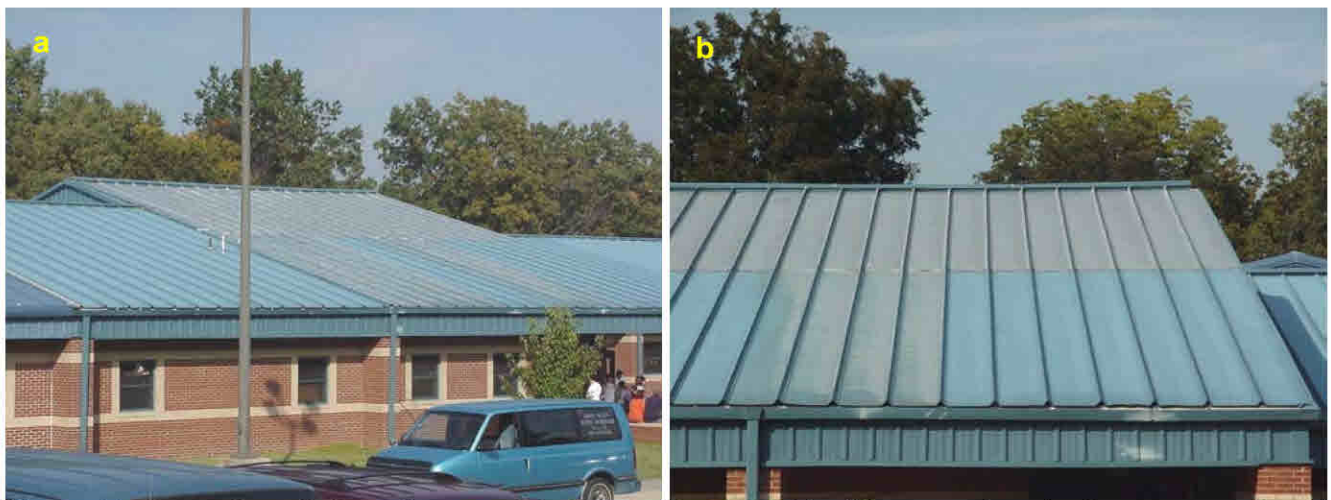
Figure 44. Non-uniform fading of a prepainted roof with noticeable differences in color from one section to another section (a) and its close look (b).

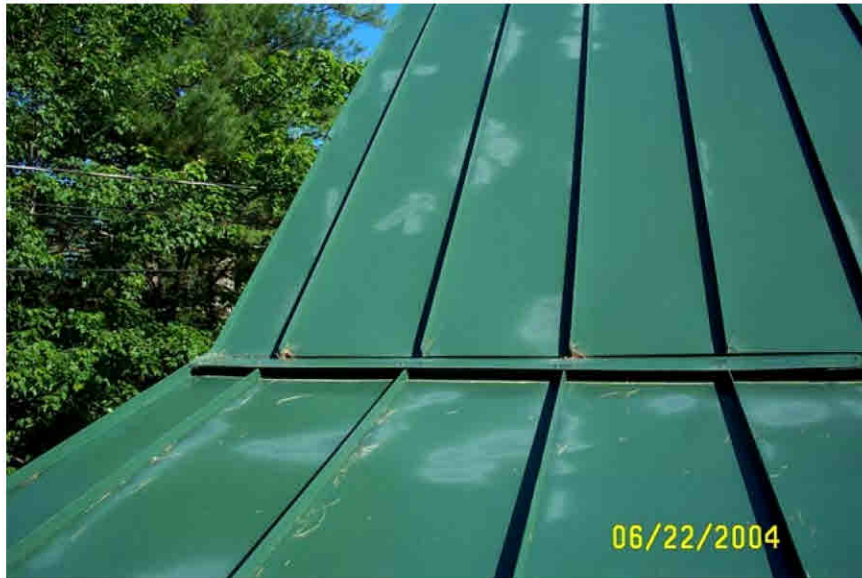
Figure 45. Differential chalking and fading appearance on the prepainted GALVALUME® steel roof with improper touch-up paint.

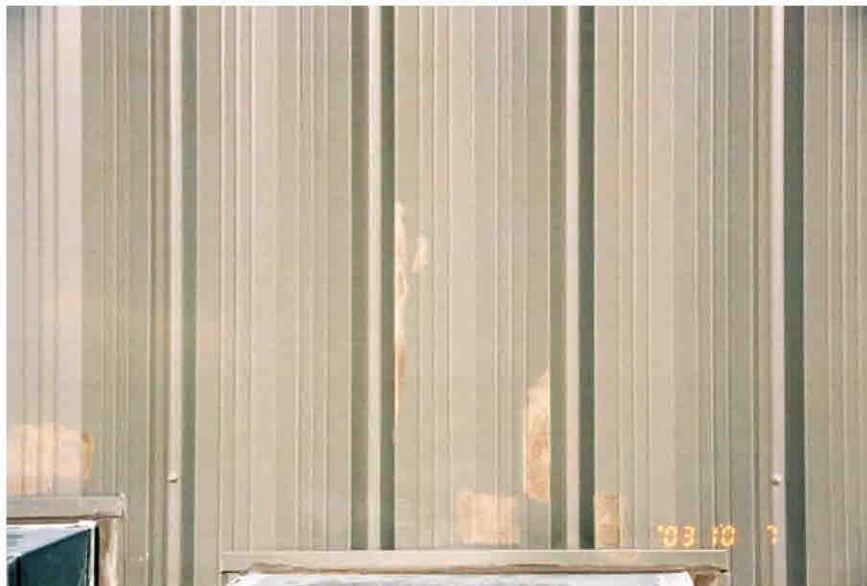
Figure 46. Differential chalking and fading appearance on prepainted hot-dip galvanized steel siding with improper touch-up paint.

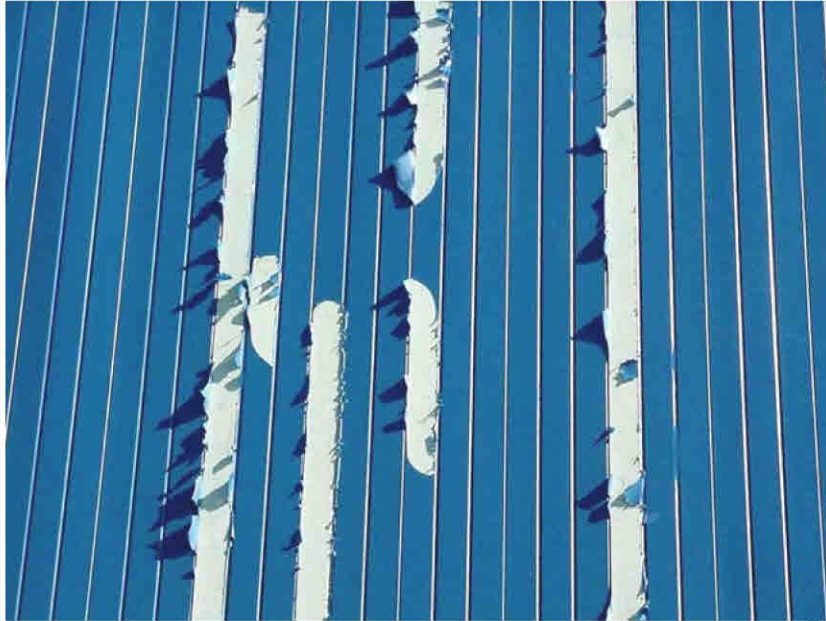
Figure 47. Inter-coat adhesion failure on a prepainted GALVALUME® panel.

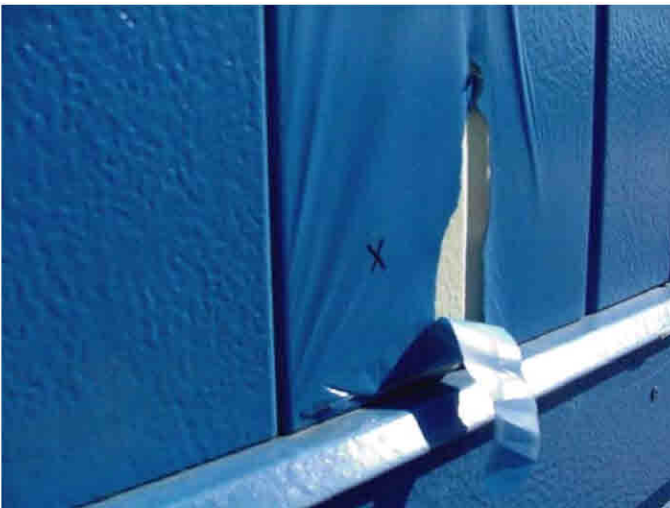
Figure 48. The topcoat delaminated from the primer.

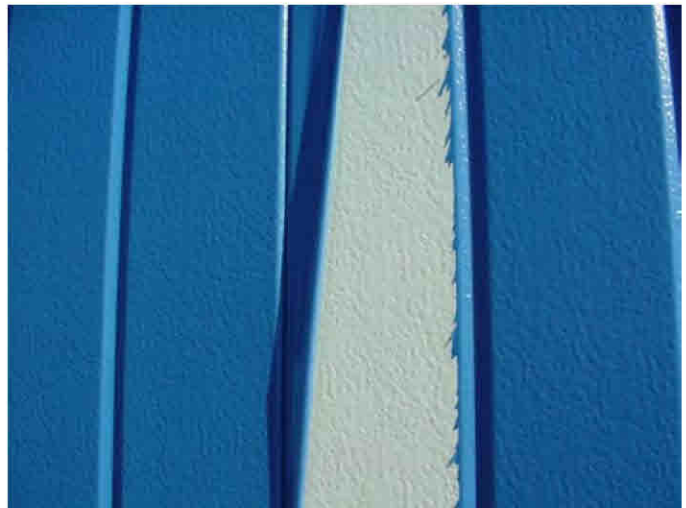
Figure 49. The primer remained on the panel where the topcoat peeled off.
